Manhole Inspection Summary

Manhole # S21MM_026MH

Insp Date: **6/29/07 10:33 AM**

Location Address: **2852 WOODBROOK-REISTERSTOWN ALLEY** Cross Street: **FULTON AVE**

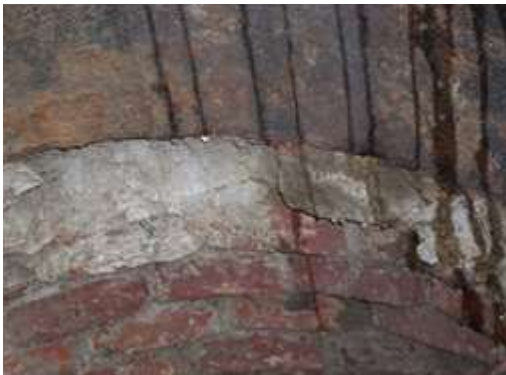
Defect 2

Chimney / Frame Adjustment ☒ Exists Material: **Brick** ☒ Parged Height: **3** (in.)
Condition: ☐ Sound ☐ Cracked ☐ Root Intrusion ☐ Loose Brick ☒ **Deteriorated**
Infiltration: ☒ None ☐ Joint ☐ Cracks ☐ Mortar ☐ Roots ☐ Wall

DETERIORATED CHIMNEY

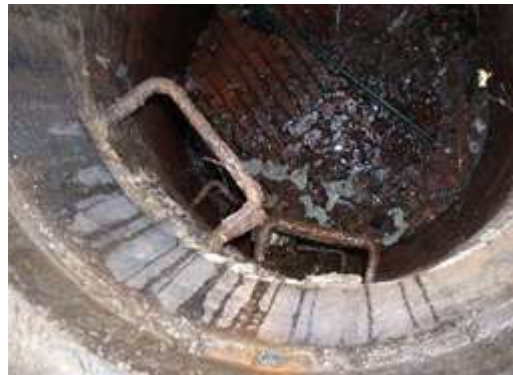
Defect 1

Steps Count: **4** Missing: **0** ☒ **Corroded**

CORRODED STEPS

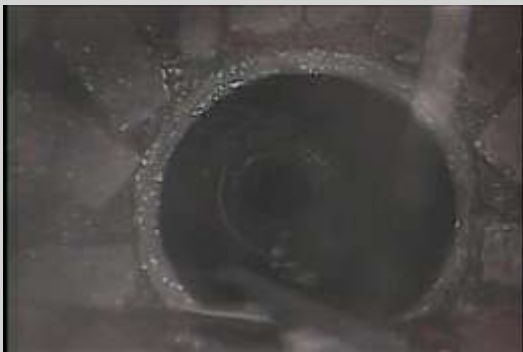
12 O'Clock Outflow

8 in. Circular Gravity Sewer
Pipe Out @ 12 O'Clock

Pipe Height: **7.2** (in.) Rod and Bar (Angled)
Pipe Material: **Clay** ☐ Pipe Lined
Invert Depth: **6.95** (ft.) Flow Characteristics: **None**
Deposits: ☒ None ☐ Mud ☐ Sludge ☐ Debris ☐ Grease
Silt Depth: (in.) Deposits Extent:
Infiltration: **None** Pipe Seal Cond: **Sound**

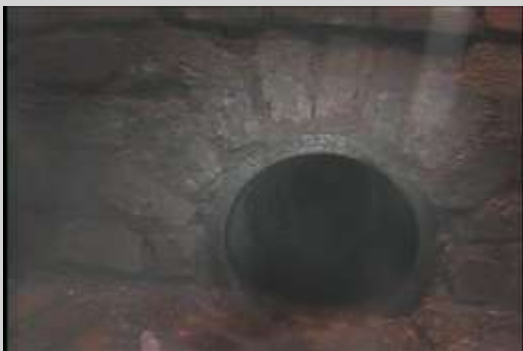
3 O'Clock Outflow

8 in. Circular Gravity Sewer
Pipe Out @ 3 O'Clock

Pipe Height: **7.2** (in.) Rod and Bar (Angled)
Pipe Material: **Clay** ☐ Pipe Lined
Invert Depth: **6.89** (ft.) Flow Characteristics: **None**
Deposits: ☒ None ☐ Mud ☐ Sludge ☐ Debris ☐ Grease
Silt Depth: (in.) Deposits Extent:
Infiltration: **None** Pipe Seal Cond: **Sound**
